M/V SIDSEL KNUTSEN downbound in the Detroit River on October 26, 2001.

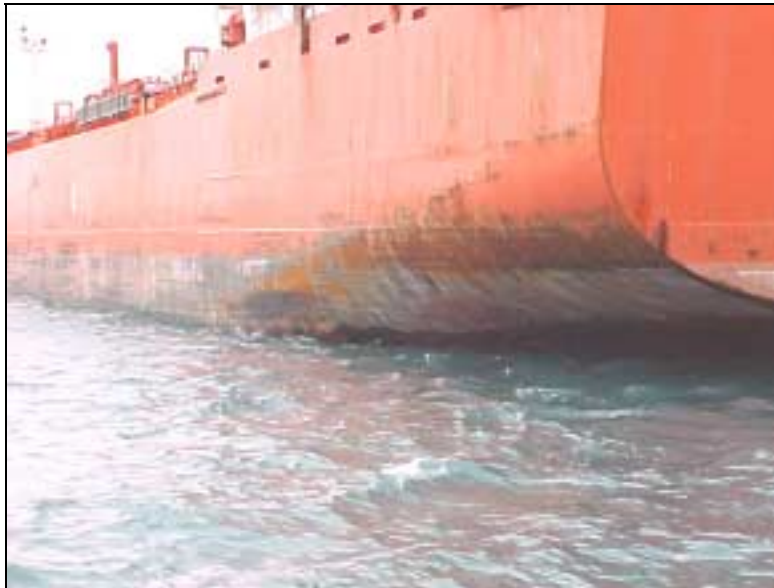
Port side SIDSEL KNUTSEN. Note the black smudge just above waterline where the turn of the bilge begins. Also note the proximity of the mark to stern. This photo was taken on October 23, 2001 at approximately 1100, 4 hours after the accident.

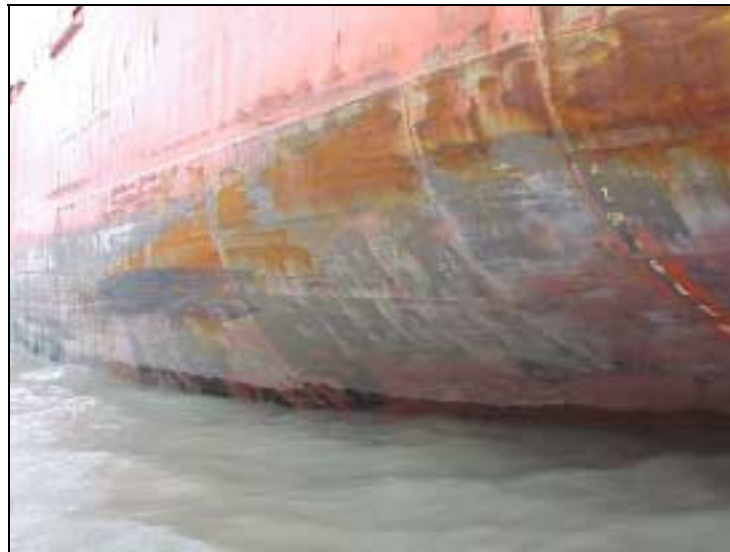
View looking forward of the black smudge marks on port side of the M/V SIDSEL KNUTSEN. These marks were created when the fender tires on the starboard side of the J. W. WESTCOTT II rubbed hard against the hull of the SIDSEL KNUTSEN. Note the semi-circular marks aft of the black tire mark. These marks appear higher than in the previous photo because this photo was taken on October 26, 2001, after the SIDSEL KNUTSEN had offloaded some of its cargo.

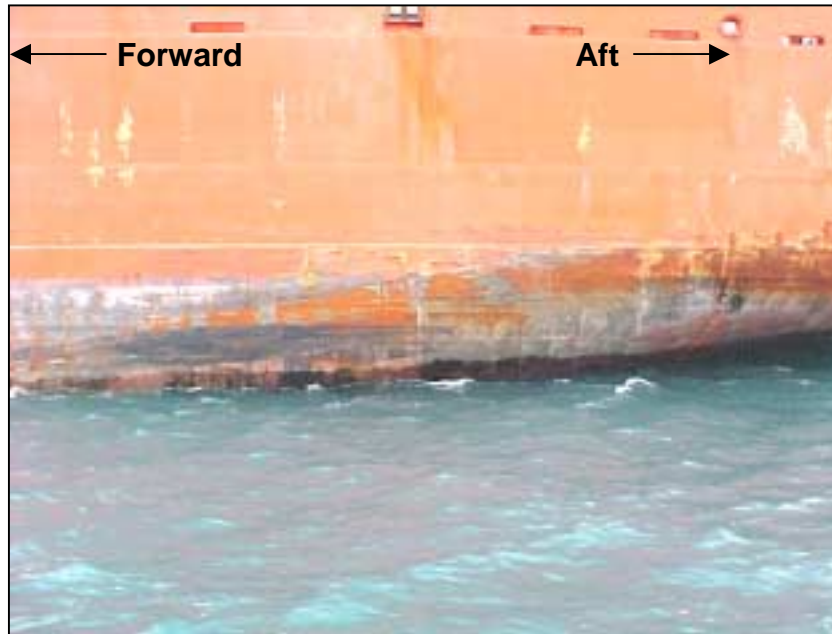
Another view of the black tire marks on the port side of the SIDSEL KNUTSEN. This mark measures 26 feet in length.
Photo taken on October 23, 2001.

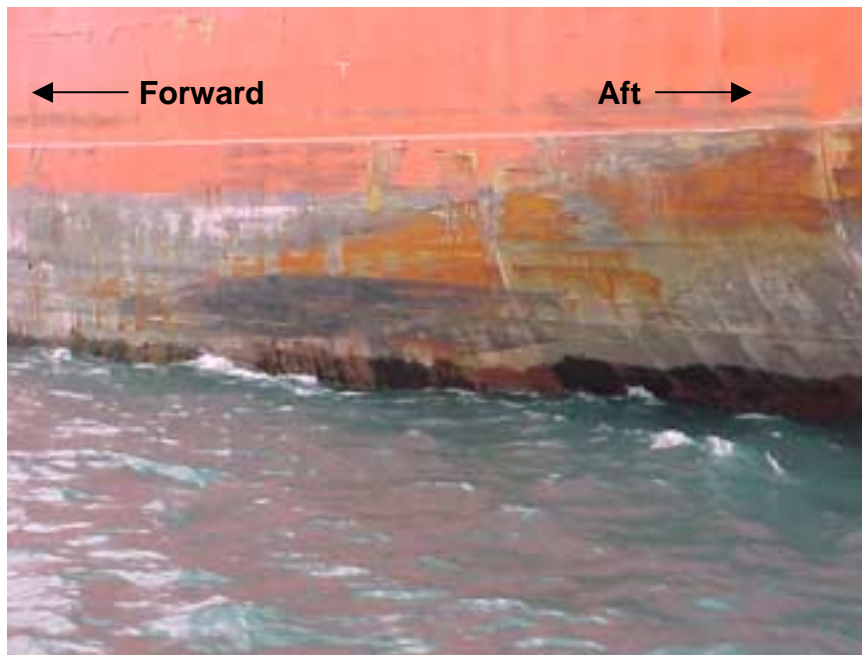
Black tire marks on SIDSEL KNUTSEN. The rust marks indicate the curvature of the hull at the turn of the bilge. Note the two semi-circular tire marks aft of the large tire mark. Photo taken on October 23, 2001.

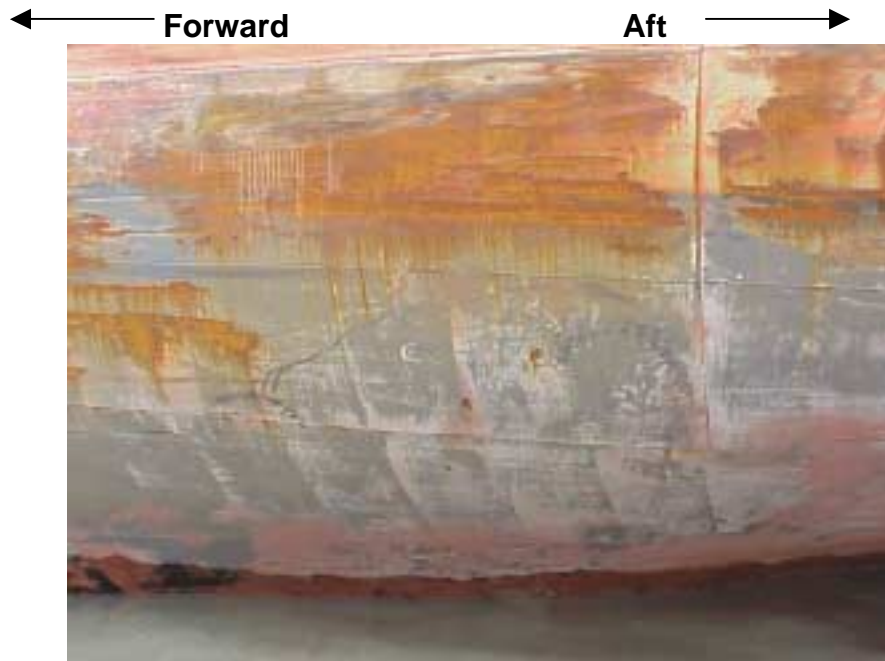
The same tire on the J. W. WESTCOTT II created these two semi-circular marks as the vessel slid along the hull of the SIDSEL KNUTSEN. Note the upward sweeping marks extending from the forward semi-circle and connecting to the aft semi-circle. Photo taken on October 26, 2001.

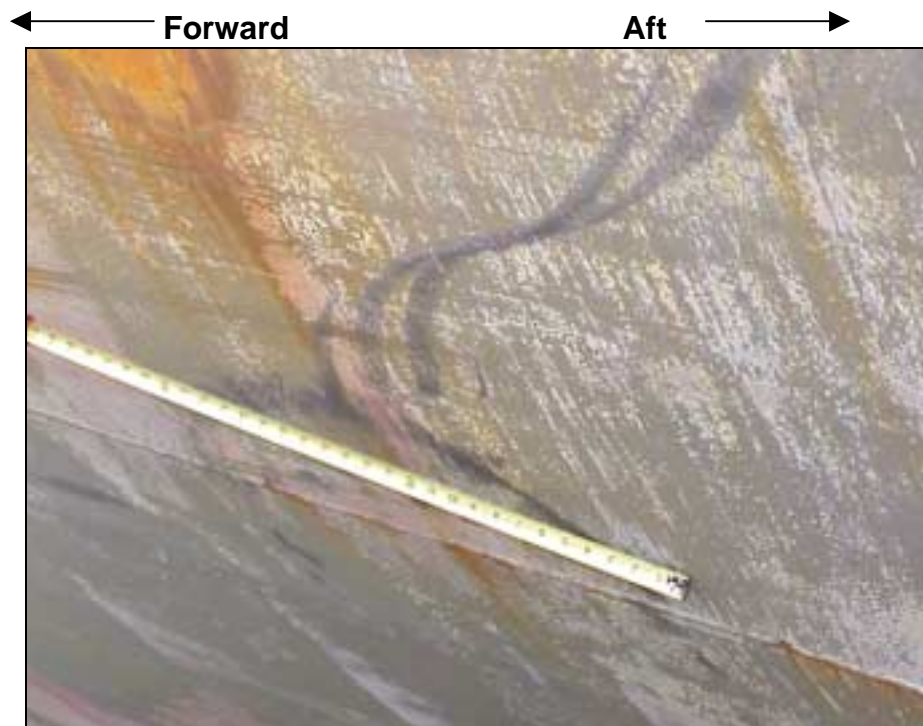
The forward most semi-circular tire mark measure 23 inches in diameter. This mark is located just under the turn of the bilge. Photo taken on October 26, 2001.

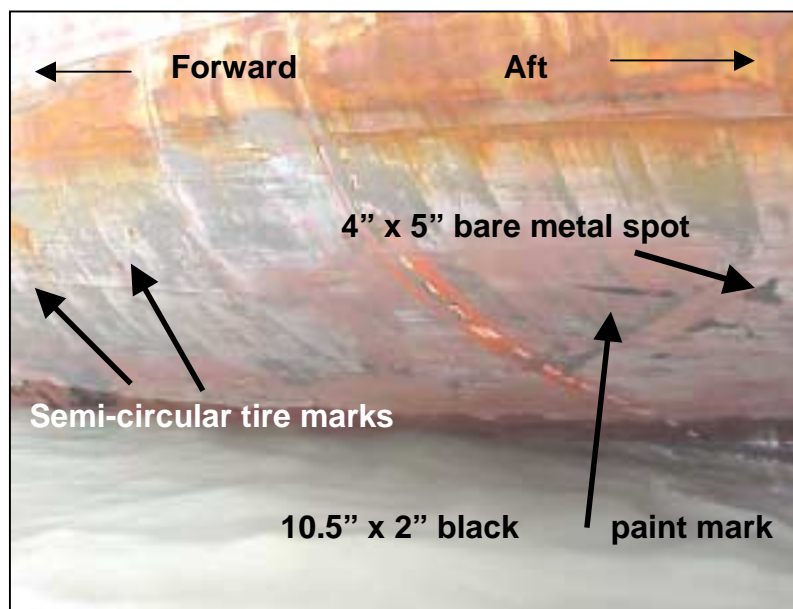
View under the turn of the bilge of the SIDSEL KNUTSEN. A 10.5" x 2" black paint mark, several smaller black paint marks, and a 4" x 5" bar metal spot are visible. The M/V J. W. WESTCOTT II created these marks as it capsized on October 23, 2001. The starboard rail or side of the WESTCOTT likely caused the black marks. Photo taken on October 26, 2001.

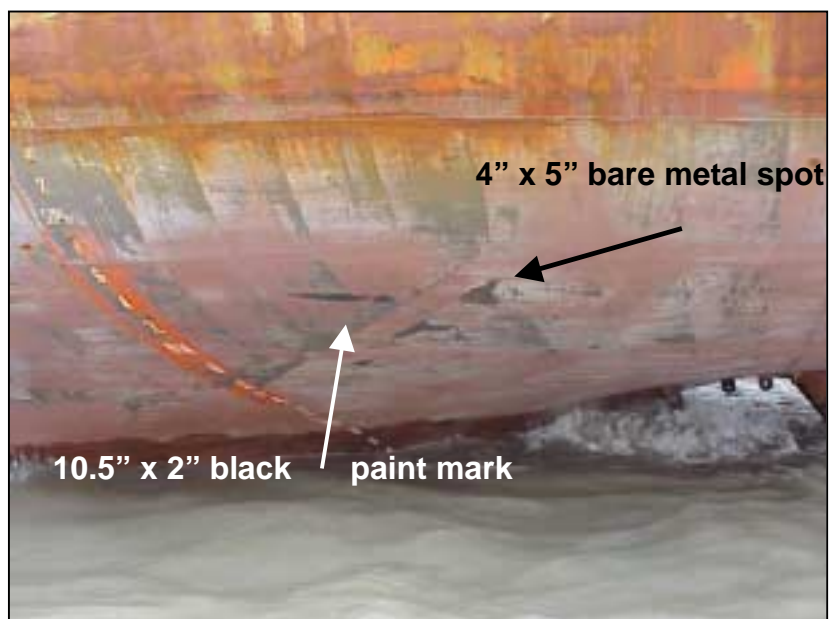
This view is taken from slightly aft of the previous photo. Note the proximity of the marks created by the J. W. WESTCOTT II to the propeller of the SIDSEL KNUTSEN. Photo taken on October 26, 2001.
